## Reportable EMP Situations

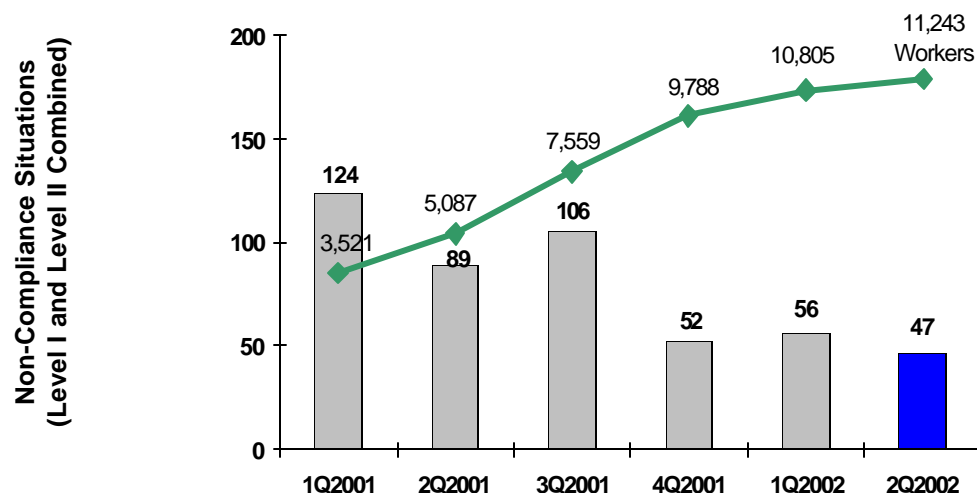
- ◀ Combined Level I and Level II Non-Compliance Situations Compared to Construction Activity (Total Workers on Job)

The combined number of Level I and Level II non-compliance situations per quarter has fallen during the overall course of the Project's construction period. During the same period the total number of Project workers, and therefore the level of construction activity, has substantially increased.
